ASK DR. GALV

Q I have a customer who would like to galvanize some tubular products for use in transmission line applications. He likes HDG's maintenance-free service life, but has heard some horror stories about galvanizing long tubular products—transmission line poles in particular. Is there any truth to such stories?

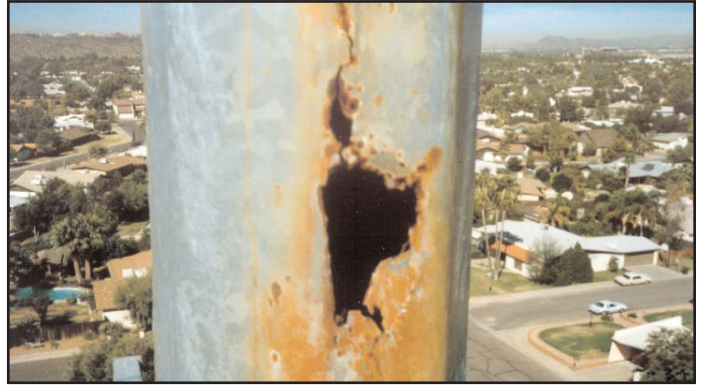
An AGA task force assembled (at this time the ADHGA). At a meeting with the APS, local galvanizers, and ADHGA, a foot section of a failed pole was presented to initiate discussion about the possible reasons for the premature failure. The tube's interior was completely corroded away in layers from the inside outward, leaving only a thin outer shell in places. The piece in question had a top plate seal-welded to the pole section, and two venting holes were positioned near the base—opposing each other—3/4" in diameter which were sealed after galvanizing with HDG plugs. APS had a chemical analysis performed on the corroded materials found on the interior of the poles, and they were determined to be rich in the chemical constituents of flux. The evidence prompted a field trip to the transmission line site. On-site inspection revealed the poles had been progressively dipped, as a visible dip line was observed. Pole tapping—an inspection where the inspector hits the pole with a hammer and listens carefully for the sounds of dropping corrosion products—discovered corrosion

throughout the line. The poles were basically sealed, preventing airflow from the exterior to the interior of the poles.

The accelerated corrosion initiating from the interior of the poles was a result of flux entrapment. The following three steps contributed to the corrosion and flux entrapment:

- **Poor venting** – The structure had only small vent holes and, in many cases, more severe corrosion was found on sections where end plates had been welded to the tubes, further limiting the flow of fluxing solutions and zinc. Additionally, since the vent holes were sealed, moisture resulting from condensation wetted the flux residues, causing corrosive chemical solutions to run the length of the interior.

These three factors added up to a case of extreme corrosion in an environment not typically characterized as corrosive. When a tubular product is progressively-dipped in a wet kettle process, the chance for flux entrapment is high. As these long tubes were lowered into the bath on the first dip, the small vent holes allowed for minimal draining of the included flux. The second dip compounded the problem as flux was entrapped at the dip line. With no interior clean-up following galvanizing, these corrosive elements were left on the surface of the poles, and the vent holes were then sealed following the progressive dip. With the changing temperatures, condensation and moisture became trapped on the interior of the poles, wetting the flux, and creating acid-like corrosive liquids that rapidly consumed the galvanized coating and the steel itself.

APS's visual inspection of the poles in service resulted in the replacement of questionable poles used in the transmission line. The ADHGA accompanied APS officials for the inspection of 184 pole sections that were scheduled to be installed; 60 poles—each showing progressive dip lines—had severe flux contamination, the corrosion on which was concentrated around the dip lines. Both the galvanizer and the APS agreed upon the treatment of the affected poles, which required the cleaning and removal of foreign materials, followed by repair of the galvanized coating.
