Q: How long is the average kettle service life and can anything be done to extend it? Are there any potential problem areas on the kettle?

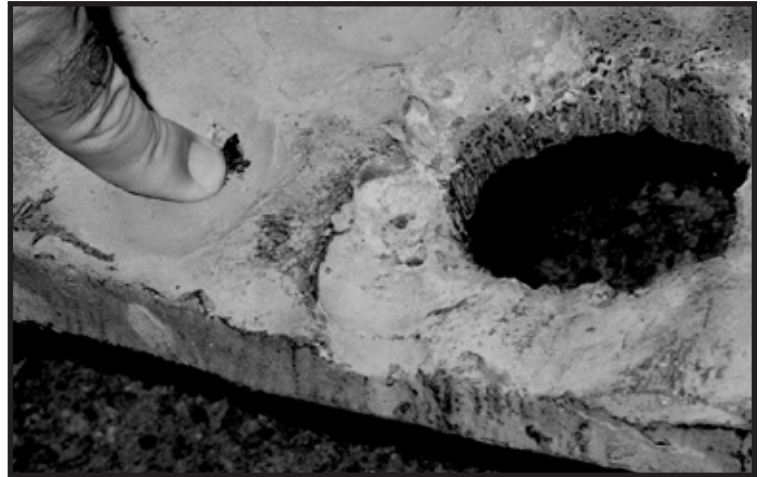
Figure 1: Kettle Perforation Failure

The survey also indicated four potential problem areas on the kettle. The dross line, thermocouple well, and brackets in the furnace cavity are areas that should be monitored closely. The dross line needs to be monitored because dross does not conduct heat as well as molten zinc and therefore is prone to cause overheating. Insulation is often applied to the outside surface of the kettle sidewall to isolate the dross from excessive heat.

The area between the thermocouple well and the kettle sidewall can accumulate dross, which will interfere with the heat transfer. The thermocouple should be located at least 2 inches from the kettle sidewall to insure proper temperature measurement and to minimize the build up of zinc residue.

Finally, if the brackets in the furnace cavity are not properly placed, they can cause hot spots on the kettle wall by interfering with the heat transfer through the wall.

Kettles should be changed on a schedule that prevents the potential of leaks or failures, yet extends the kettle service life as long as possible. Always have a spare kettle ready in case of premature kettle leaks and probe the kettle wall for low spots when the service life approaches 5 to 7 years.
