# ASK DR. GALV

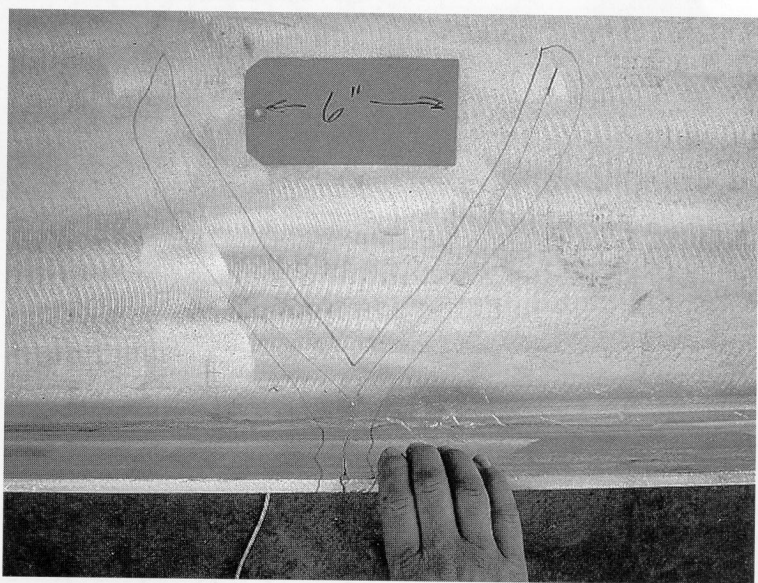
As an example, one galvanizing company called us a short while ago with a not so typical story. Some I-beams that were galvanized exhibited cracking in the web of the I-beam. The pictures below show how severe this cracking became. The second beam almost cracked into two pieces. The galvanizer immediately identified the problem to his customer and then the fun started.

Figure 1. I-Beam with Y-shaped crack in the web of the beam.

crack before hot-dip galvanizing. It was time for a detailed examination of the beams. Four black beams were spot checked with magnetic particle testing and all four showed evidence of cracks in the flange area. The number of micro cracks that were found by magnetic particle testing was in the hundreds and there was a pattern to the cracking. The cracks were located along the flange of the beam every ten feet. This was almost the same pattern as the stamped logo of the steel manufacturer, but the logos appeared every five feet. The steel manufacturer reported to the group that their logo pattern was indeed every ten feet, in the same location as the cracks.

The steel manufacturer described the process of producing the beam and the logo pattern was hot stamped every ten feet along the flange. The beams were then cold bent before galvanizing to produce a curve in the beams. The cold bending process had put so much strain on the areas around the logos that micro-cracks had developed. The steel metallurgists then told the group that the hot-dip galvanizing process was not the cause of the cracks and had actually helped find the cracks before the beams were put into service. The other logos that were seen between the stamped logos were generated during the bending process and they did not have cracks.

The solution to this particular problem would be to grind out the cold-formed logos prior to galvanizing to prevent strain-age embrittlement of the I-beam after the galvanizing process. If the micro cracks that were formed from the cold-worked logos are ground out, this will eliminate the potential for strain-age embrittlement.

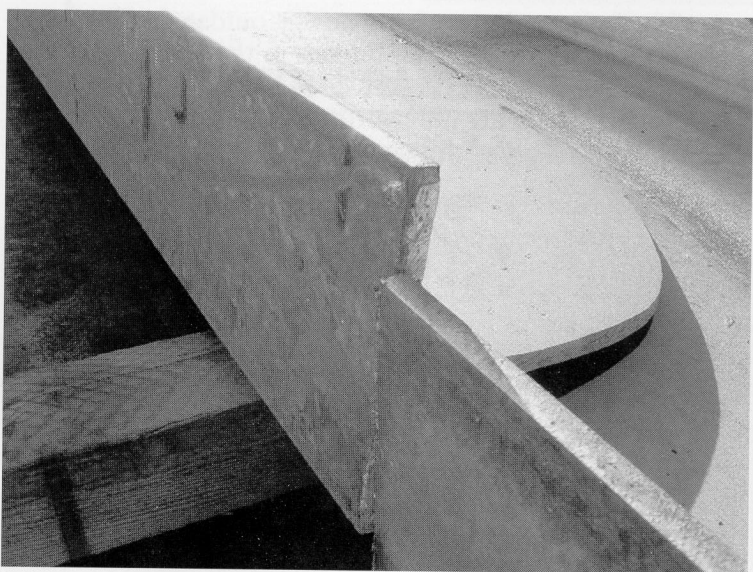
Figure 2. I-Beam with web and flange crack.
