# WET STORAGE STAIN

## A Pictorial Explanation

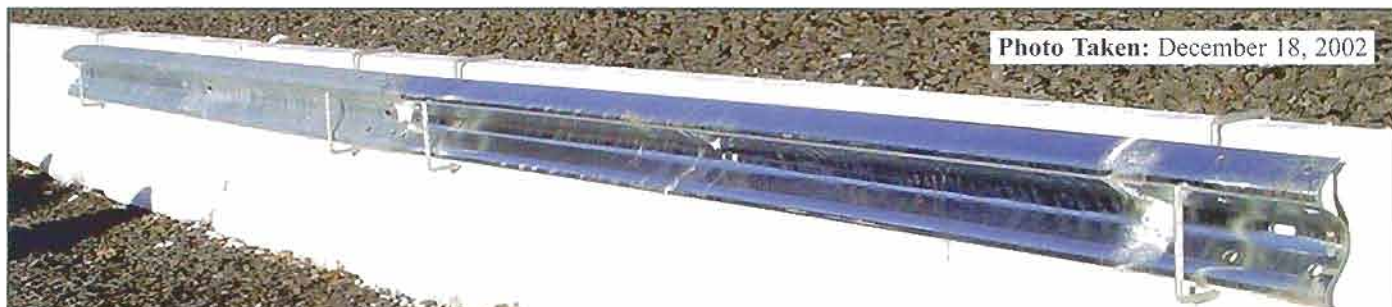
The two guardrail sections depicted above were hot-dip galvanized on the same day.

- The dull-gray section of guardrail on the left side of the picture was taken from the interior of a stack of hot-dip galvanized guardrail that was exposed to moisture (humidity or rain) but not exposed to freely-flowing air. As a result, these sections of guardrail formed a zinc corrosion product film (wet storage stain) over a period of one week.
- The shiny section of guardrail on the right side of the above picture was galvanized and stored under cover while exposed to freely-flowing air.

Both sections were attached to the posts of the concrete barrier on the same day (December 18, 2002).

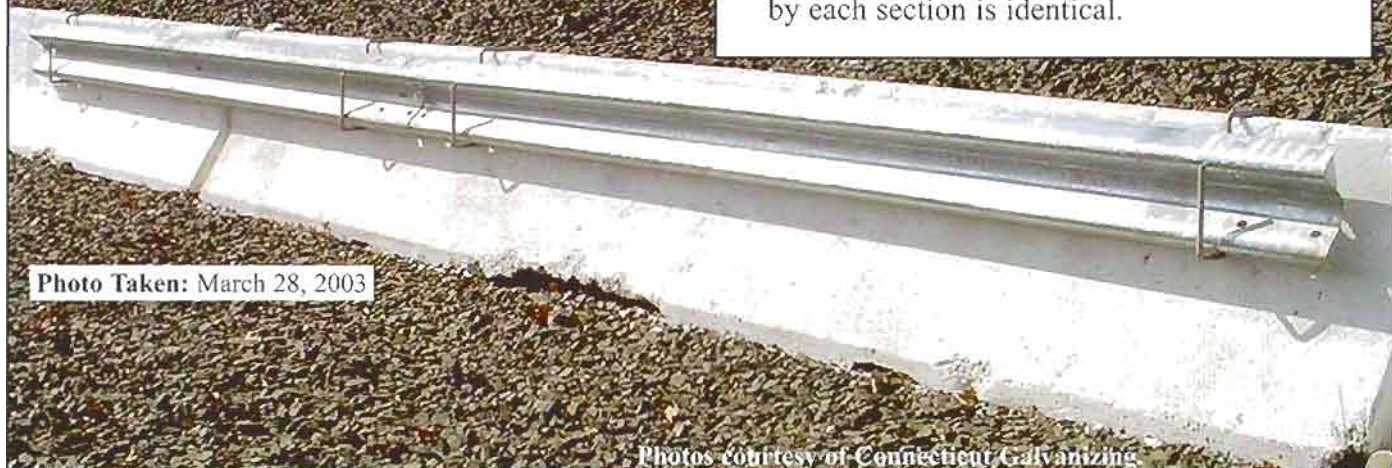
The photo below depicts the same guardrail sections 3½ months after they were first attached to the concrete barrier.

- The left section of the guardrail — which was already dull-gray in appearance due to the rapid formation of wet storage stain from damp, unventilated storage conditions — now matches the right piece of guardrail that was originally bright and shiny.
- When hot-dip galvanized steel with light-to-moderate wet storage stain is ultimately exposed to freely-flowing air, the zinc corrosion products react with carbon dioxide to form the matte gray zinc carbonate film that we recognize as the stable patina that gives hot-dip galvanized steel its incredible resistance to corrosion.
- The section on the right progressed in a normal fashion to the zinc carbonate stage, and the corrosion protection provided by each section is identical.
