What Affects Zinc Coating Thickness on Galvanized Steel?

Webb Avenue Bridge Performs Perfectly

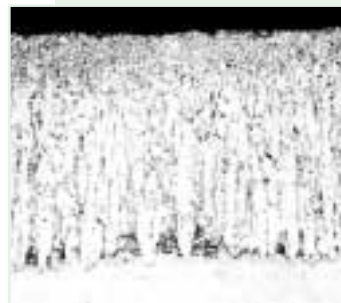
The compound layers of zinc and iron will be greatly increased when steel with any of these excessive chemistry combinations is hot-dip galvanized. Typically, this is not a desirable occurrence and should be avoided. Communication among the galvanizer, specifier and fabricator will help avoid this problem.

The thicker composite coating that steel with those characteristics causes may result in the final pure zinc coating not being established. It will often result in more of a matte or mottled finish. ASTM A385 contains more information regarding how steel with any of those chemical compositions affect the galvanized finish.

A photomicrograph of a galvanized coating on high silicon content steel.

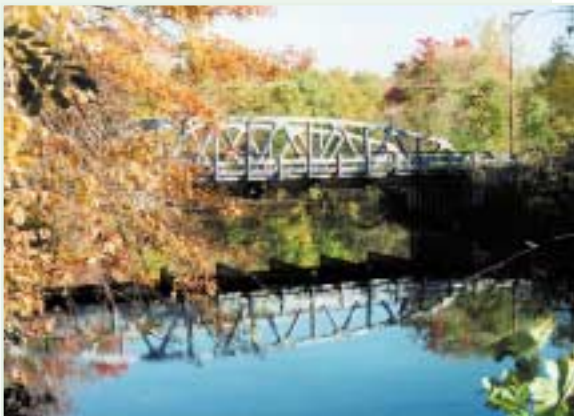
This fully galvanized truss bridge is performing well after five years of service in a moderately industrial corrosive environment. See story on page 2.

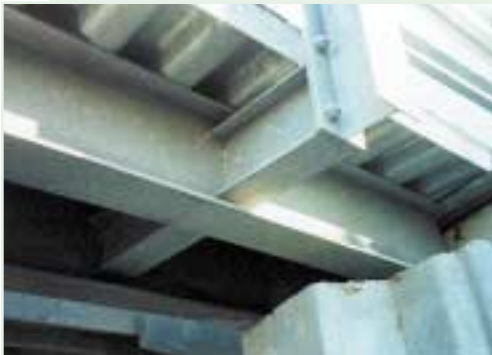
View at south end of abutment

The bottom chords of the bridge tend to trap dirt and gravel, but the galvanized coating is holding up well, with a small amount of normal discoloration.

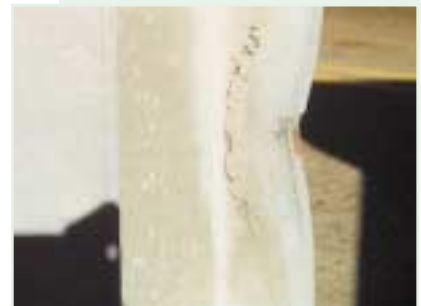
There are two locations on the bridge where collisions have dented the structure.

Both show very small areas of corrosion around the immediate impact area and have been very well protected by the sacrificial/cathodic nature of the zinc.

Collision damage to vertical truss chord.

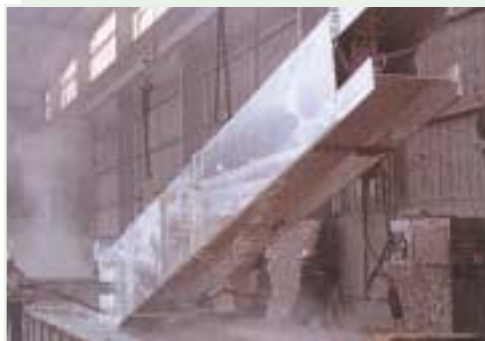
Double-dipping the second portion. The line is clearly visible here.

The coating may appear uneven at the double-dipping line, due to the fact that it is overlapped. The appearance will not affect performance.
