Q: When galvanizing a frame structure, we took it out of the kettle, and I noticed some small cracks around one of the weld areas. What is causing this cracking?

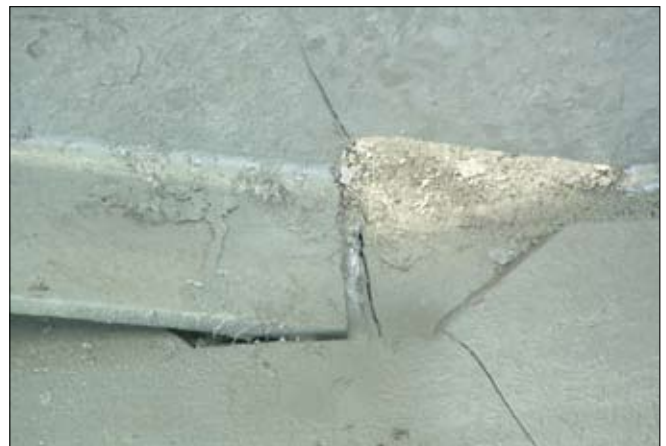
Zinc can be pulled into a crack by wicking action, which will cause the crack to expand and grow.
