# Ask Dr. Galv

Dear Dr. Galv: I've been doing boat trailers or hand rails for a number of years and every once in a while the coating will come out looking very rough. Why is this happening and why does it happen in the center section of the part?

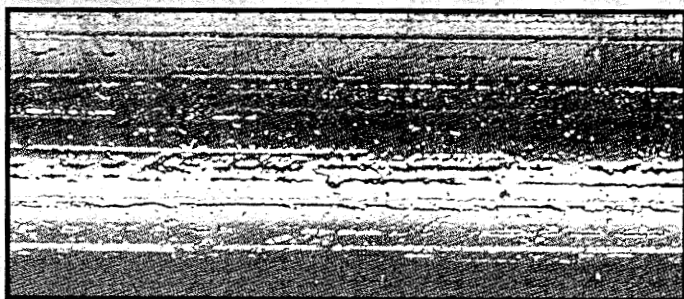
A. There are a couple of reasons that galvanizers may find a very rough coating on a part such as a boat trailer or a section of hand rail. The most obvious reason is the fabricator used a different piece of steel for one section of the assembly. The different piece of steel had high levels of silicon or phosphorous and was very reactive, causing the thick and rough coating. The rest of the assembly may be smooth and normal appearing galvanized coating. The inclusion of a reactive piece of steel in the assembly is apparent when the rough coating stops abruptly at a weld line or assembly joint. Sometimes it is an attached bracket or clip which has the rough coating. In the case of hand rail, this rough coating may be the cause for rejection of the assembly since the hand rail must be smooth for people to run their hands along.

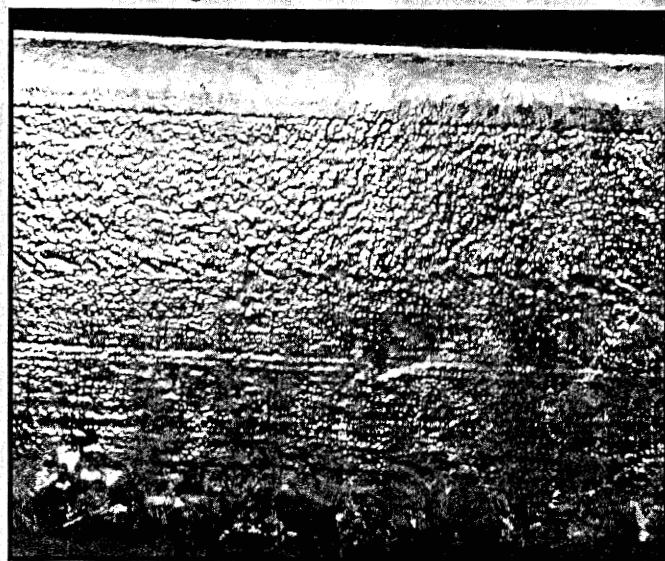
The assembly with this steel chemistry showed rough coatings on some of the pieces. The picture shows the rough appearance of the coating. This looks like the typical example of high phosphorous steel but the actual reactive element is the silicon. The silicon level of 0.06 puts the steel on the leading edge of the Sandelin peak. Added factors such as cold working the tubes to form the shape of the boat trailer and the temperature cycle for the section of tubing in the center of the assembly add to the silicon reactivity. The silicon is on the edge of the reactivity curve and will cause problems on some pieces and not on others. This can be very difficult to diagnose.

These assemblies will provide adequate corrosion protection but may be difficult to deliver to a very particular customer because of the rough coating appearance. As a galvanizer, there is very little that can be done about this rough appearance because the problem is caused by the steel chemistry. Steel heat chemistries are an average of sample pieces and do not always reflect the actual chemistry of the tubing parts.
