Ask Dr. Galv

Q: One of my customers called saying I didn't galvanize the whole part, and it was already starting to rust. What should I do about it?

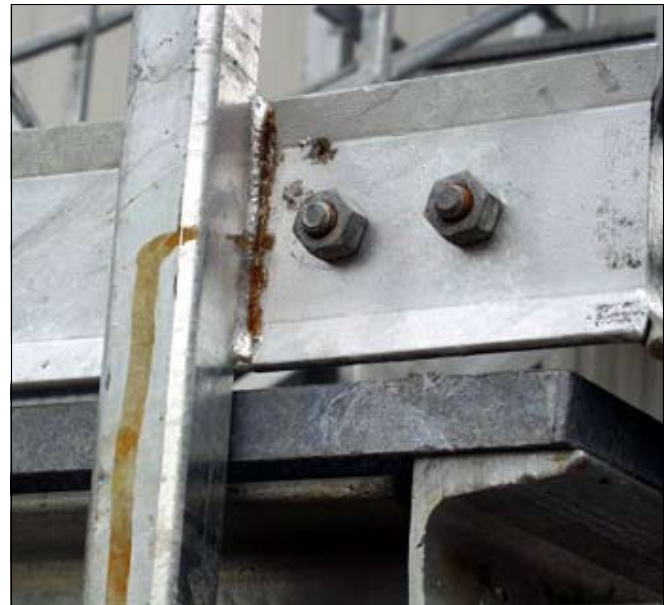
A: The customer then described what he was seeing. Along the edge of a weld between a tube and a structural member, there was a trail of rust leaking down the tube. The galvanizer was finishing up the job, and the owner asked him why the parts were already starting to rust even before he was finished with the job.

This situation is very common due to a couple of decisions made by the fabricator and designer early in the design phase of the project, or due to a welding procedure that does not produce a full seal weld. The rust bleeding comes from the interaction of moisture, cleaning chemicals, and uncoated steel surfaces. When combined, these components will produce rust very quickly and the rust will then follow the path of gravity and cause iron oxide streaks down the sides of hot-dip galvanized surfaces.

The design decision causing the potential for this rust bleeding is welding parts together as the method of joining and leaving enclosed areas behind the welds. Sometimes this design decision can mean large areas of trapped air would be produced unless the enclosed area is vented properly per ASTM A 385. The venting of these large trapped areas then provides a route for the cleaning solutions to penetrate the area. Rinsing out the chemicals can be very difficult due to the orientation of the vent holes or the placement of the vent holes, and due to the thin gap between the steel pieces.

Rust bleeding results from the interaction of moisture, cleaning chemicals, and uncoated steel surfaces where a full seal weld was not achieved during the design/fabrication phase.

What do you do about the rust bleeding? The best answer to this question is to first clean off the rust, and then to try to plug the vent or welding hole with some type of silicone material to prevent moisture from entering the trapped area. This is only a temporary fix, and the silicone material will need to be maintained over time to keep moisture out of the trapped area. The best solution is to plan on using a gap of 3/32 in. between two pieces to be welded before galvanizing, as this will allow zinc metal to fill the area between the pieces during galvanizing and produce an even better joint than welding alone.
