Q: I did everything I could to make sure the steel part came out of the galvanizing kettle with a bright and shiny coating, and then I checked underneath the top flange of the beam that I was galvanizing and all of these black skimmings were on the coating right below the flange. What do I do with these black skimmings?

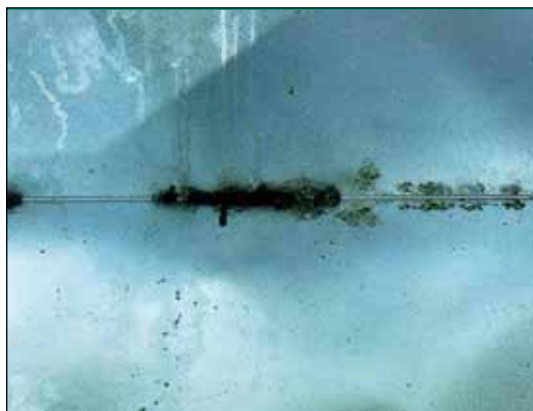
Figure 1

A: The exposure of molten zinc metal to air results in a thin layer of zinc oxide formation on the surface of the molten metal. This layer can also contain small amounts of zinc chloride or ammonium chloride from the flux. This material forms a black powdery substance when trapped on the surface of the galvanized coating, as *Figure 1* evidences. According to ASTM A 123 section 6.4 on appearance, this substance is not prohibited from the coating surface.

This powdery material can be removed with a nylon bristle brush or with a hand grinder, just remember not to take too much zinc away when removing the skimmings.

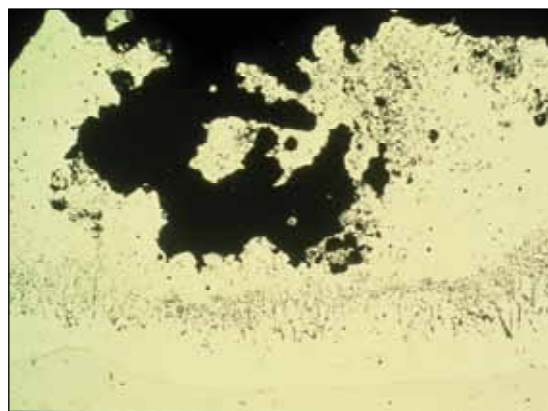
Figure 2

The reason that this material is allowed to reside on the surface of the coating is that there is good galvanized coating underneath the black powdery substance. The micrograph in *Figure 2* shows the black zinc skimmings at the top and the intact coating underneath the black powder. Since there is coating underneath the powder, the corrosion protection is not affected by the black substance.
