Q: My galvanized rebar cracked soon after galvanizing. What happened?

A: The first thing that pops into a galvanizer's customer's mind when their galvanized rebar cracks is the steel suffered from hydrogen embrittlement during the galvanizing process. This diagnosis is incorrect.

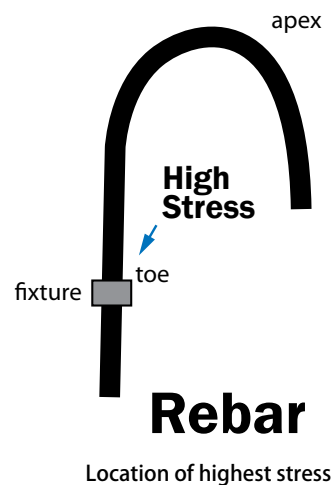
The diagram above right illustrates the area of highest stress when bending rebar. When the steel is bent, it would seem like the highest stress point would be at the apex of the bend.

This is not the case. The area of highest stress is at the toe of the bend, not the apex. The toe of the bend experiences the highest stress because as the rebar moves to form the bend, the steel in the holding fixture remains static. This means one part of the rebar moves while the other part doesn't move. If the rebar cracks, it will likely occur in this area.
