ASK DR. GALV

Q I just galvanized a load of handrail. The parts came in very smooth, as the fabricator took extra care to make sure all of the welds were ground smooth. But, when I finished the galvanizing, the welds looked like big “speed bumps” on the surface. What happened and what do I do about it?

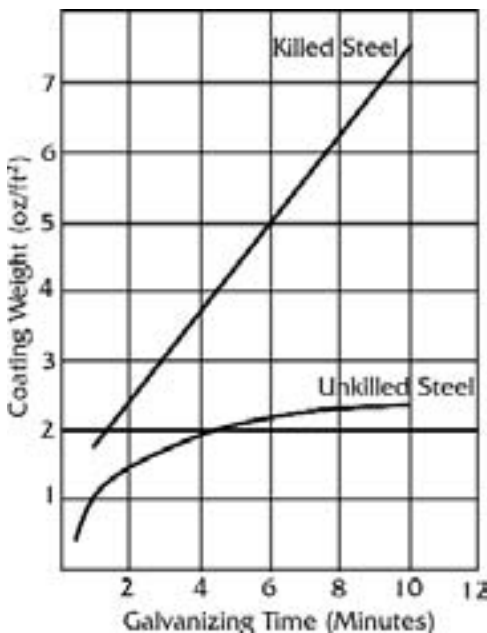
A The hot-dip galvanized coating is formed by the interdiffusion of the zinc from the galvanizing bath and iron from the steel or weld material. One of the major contributing factors in galvanized coating growth is the amount of silicon present in the steel or weld material. Amounts less than 0.04% are considered low silicon, amounts between 0.15 and 0.25% silicon are considered moderate silicon, and amounts between 0.05 and 0.15% and amounts over 0.25% are considered high silicon. When the steel or weld material contains high silicon levels, the hot-dip galvanizing reaction continues to proceed in a linear relationship, as shown in the figure, below. When the steel or weld material contains low or moderate silicon levels, the hot-dip galvanizing reaction tapers off after the coating reaches a certain thickness, as seen in the lower curve:

Killed steel represents the HDG coating growth with high silicon levels in the steel or the weld material. Unkilled steel represents the galvanized coating growth with low or moderate silicon levels. As you can see on the chart, if the parts are left in the kettle for five minutes, a typical

galvanizing time for handrail, the coating weight for low or moderate silicon containing steel is 2.0 oz/sq ft and this corresponds to a thickness of 3.4 mils of coating or 85 microns of coating. If the parts contain high silicon levels and are left in the kettle for five minutes, the coating weight is 4.25 oz/sq ft and

this corresponds to a thickness of 7.0 mils of coating or 180 microns of coating. The high silicon steel has more than twice the coating thickness as the low or moderate silicon steel when immersed at the same time.

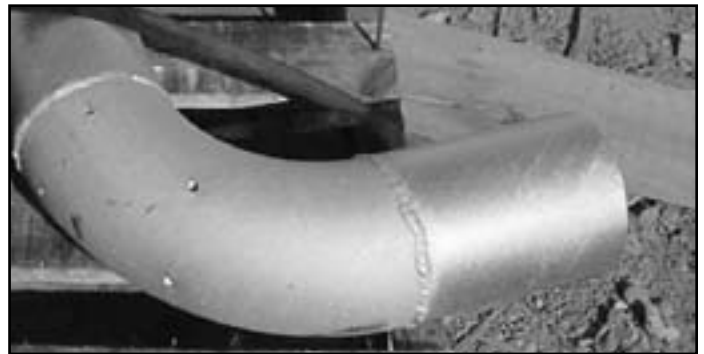
Back to the handrail question . . . The fabricator has assembled the handrail with a weld material that contains high silicon levels. This material will form a much thicker galvanized coating than the tubing on either side of the weld. The fabricator probably took a significant amount of time and effort to make sure the weld areas were ground smooth because the part would be used for handrail. It will be very disappointing to him to see, after galvanizing, that the weld now looks like a “speed bump” on the otherwise smooth handrail. The problem can be avoided if the fabricator uses weld rod materials that are compatible with the silicon levels of the tube steel used in the handrail. The AGA website has information on the proper weld rod materials to use before hot-dip galvanizing at <http://www.galvanizeit.org/content/index.cfm?fuseaction=showContent&contentID=168&navID=210>.

The picture below shows three different steel materials. The low silicon material shows a bright and shiny coating, the high silicon pipe material shows a dull grey look, and the high silicon weld material shows the look of a “speed bump” on the part. This is not what the customer expected just looking at the “before galvanized” steel part. The silicon level differences cause this change in appearance and coating thickness, not the galvanizing process.

If the problem already exists, some galvanizers have tried to strip the coating off the handrail and re-galvanize the parts. This meets with limited success. Sometimes the silicon in the weld material near the surface is reduced enough that the second time it is coated the coating does not cause a bump appearance. Most of the time the problem just reappears on the part after the second galvanizing operation. A different solution that many find the least expensive is to grind down the thick coating in the weld areas so the handrail is smooth all around; this may make the appearance of the handrail less desirable. After a year of aging, the appearance difference will be significantly less noticeable. The last resort may be to remake the handrail with the properly matched weld material.
