DR. GASK GALV

Q I recently galvanized a large overhead sign structure and was quite surprised that it cracked significantly around the weld areas after galvanizing. I wasn't aware that welded material that is going to be galvanized has the potential to crack. What is the cause of this cracking? Is there anything I can do to prevent this from occurring in the future?

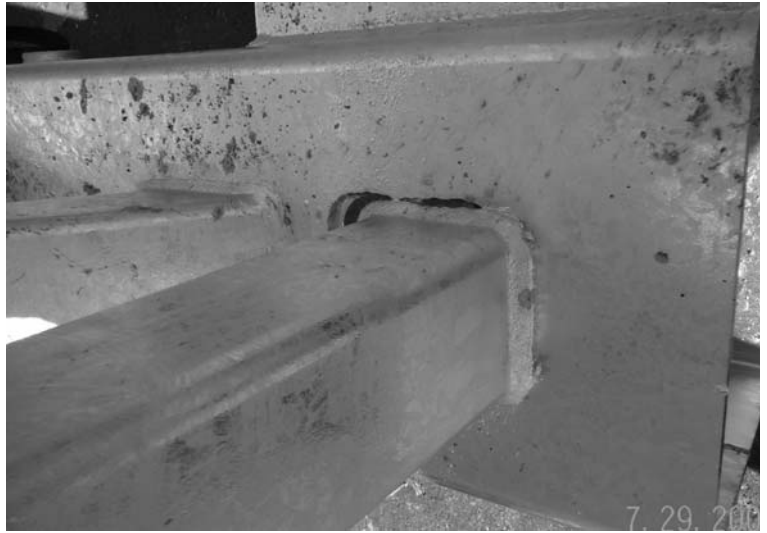
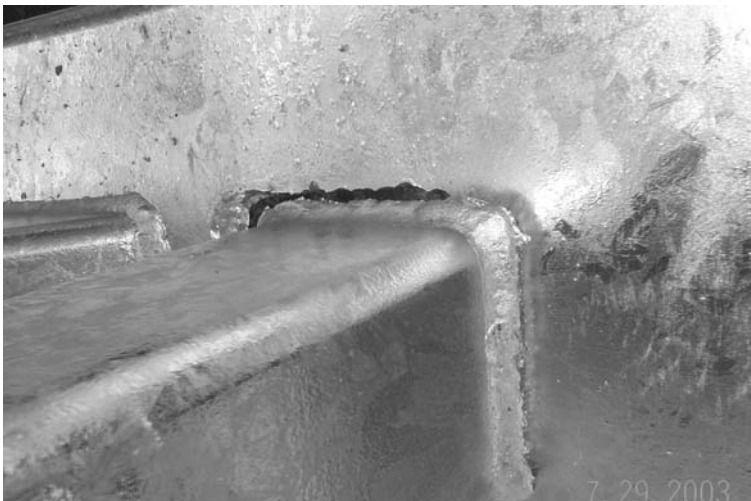
A The cracks found in your galvanized steel can be attributed to stresses introduced during the welding of two different thicknesses of steel. The stresses from the welding are from the weld metal itself, as it is typically harder and stronger than the base metal, and from the heat applied during welding. The welding process can increase the hardness and reduce the ductility of steel in the heat-affected zone, making it more susceptible to brittle fracture. Another factor that could potentially play a role in the cracking is hydrogen embrittlement. Harder, stronger steel is more susceptible to hydrogen embrittlement.

The weld metal and heat affected zones can obtain hardness values much higher than other areas of the steel. The hardness of steel is directly proportional to the tensile strength of the steel. If weld areas or heat affected zones obtain hardness values above 35 Rockwell C (steel with a Rockwell C hardness of 35 correlates to a tensile strength of 160 ksi [160,000 psi]), they are susceptible to hydrogen embrittlement. One study's results suggest that steels with hardness values above this are highly susceptible to cracking, especially when put under load.

hardness values could potentially be high. Also in these areas is the combination of two different thickness steels, which will expand and contract at different rates, adding even more stress to an already highly-stressed area.

The fact that welding stresses are partially relieved in the galvanizing kettle, and the combination of different section thicknesses thermally expanding and contracting at different rates, combined to cause the cracking in your sign. As you can see from your pictures, all of the cracking originated in the weld area, particularly in the heat-affected zones where the

The answer to avoiding this problem (and most others) is to relieve stress. One such stress-relieving procedure can be found in ASTM A 143, *Standard Practice for Safeguarding Against Embrittlement of Hot-Dip Galvanized Structural Steel Products and Procedure for Detecting Embrittlement*. Although welding is not specifically mentioned, a method for stress relief is explained. Included in Section 5.3 is a statement that details the procedure for stress relieving cold-formed steel and can be applied to relieving stresses from welding. It states that stress relieving should be conducted at a maximum of 1100°F (595°C) for approximately one hour per inch (25.4 mm) of section thickness.

The heat treatment of steel prior to galvanizing will relieve stresses in the steel and reduce the potential for cracking. It will reduce hardness values in the weld material and, more importantly, the heat-affected zone. There are many factors that can play a role in the cracking of structural steel. Designing fabrications to eliminate zones of high potential stress, or relieving these stresses prior to galvanizing, should eliminate future cracking in these structures.
