Q: My galvanized rebar cracked soon after galvanizing. What happened?

A: The first thing that pops into a galvanizer's customer's mind when their galvanized rebar cracks is the steel suffered from hydrogen embrittlement during the galvanizing process. This diagnosis is incorrect.

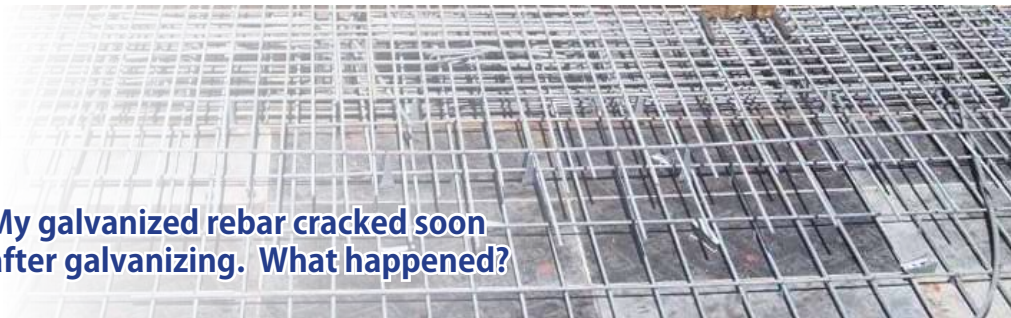
The diagram above right illustrates the area of highest stress when bending rebar. When the steel is bent, it would seem like the highest stress point would be at the apex of the bend.

This is not the case. The area of highest stress is at the toe of the bend, not the apex. The toe of the bend experiences the highest stress because as the rebar moves to form the bend, the steel in the holding fixture remains static. This means one part of the rebar moves while the other part doesn't move. If the rebar cracks, it will likely occur in this area.

There are several ways to prevent strain-age embrittlement of galvanized rebar. The first method is to bend the rebar after galvanizing; however, this can result in flaking and cracking of the galvanized coating. Flaking and cracking of the galvanized coating are not rejectable under ASTM A 767/A 767M. Those areas can be repaired using zinc-rich paint. Heating the bend areas with a torch to apply zinc solder is not recommended because it can strain-age the steel due to the elevated temperature of the torch.

Another method to reduce the possibility of strain-age embrittlement is to follow the bending diameter recommendations in ASTM A 767/A 767M. By following these recommendations, less stresses are induced into the steel. If rebar is required to be bent tighter than these recommendations, it can be stress relieved at 900 F to 1050 F (480 C to 560 C) for one hour per inch of bar diameter.
