What Affects Zinc Coating Thickness on Galvanized Steel?

Webb Avenue Bridge Performs Perfectly

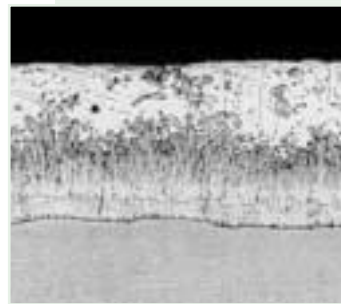
A photomicrograph of a typical galvanized coating.

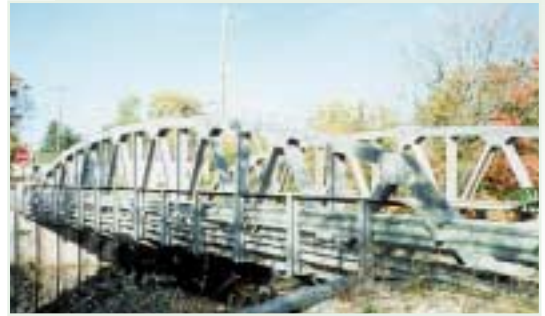
Webb Avenue Bridge

The steel was judged to have a clean, flat appearance with minimal signs of weathering. The handrail coating thickness was measured at 8.9 mils, almost three times the required thickness for handrails. Structural members ranged in coating thicknesses from 10.5 to 14.5 mils.

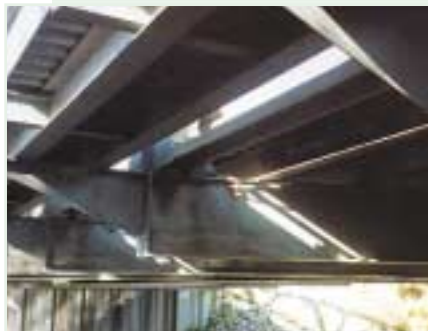
View of the underside of the bridge

The bottom chords of the bridge tend to trap dirt and gravel, but the galvanized coating is holding up well, with a small amount of normal discoloration.
