Q Our galvanizing bath has encountered some floating objects that look a little bit like dross. It often ends up on the product. What is this stuff?

First of all, what is floating dross?

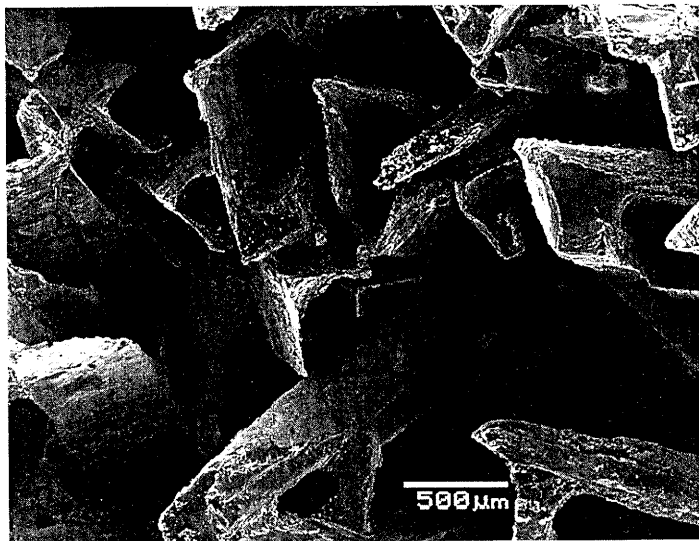
Figure 1

islands at or near the surface of the bath. When viewing the clumps under a high powered microscope (Figure 1) these spikes appear as needle-like crystals or straws.

When viewing the microstructure (Figure 1) of the floating dross the long hollow spikes show up quite well. The elongated structure implies that there is growth across a temperature gradient. The density of the intermetallics is slightly heavier than liquid

zinc, and the elongated straw-like form of the inter-metallics probably helps them float to the top as opposed to sinking to the bottom like other dross particles.

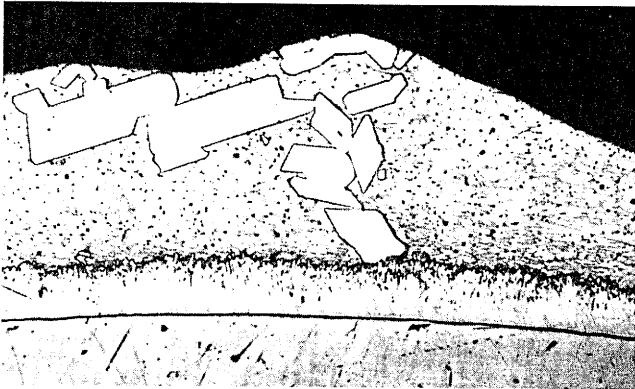
Figure 2

Dross can become attached to the galvanized product and cause unsightly protrusions or pimples as shown in Figure 2. Bottom dross that is floating in the galvanizing bath, due to temperature inversions, may adhere to the surface of the part being galvanized. This dross becomes encapsulated in the free zinc (Zn) layer during withdrawal, causing excess
