Hot-Dip Galvanizing vs. Paint in Life-Cycle Assessment

Case Study # 1 – Balcony Structures

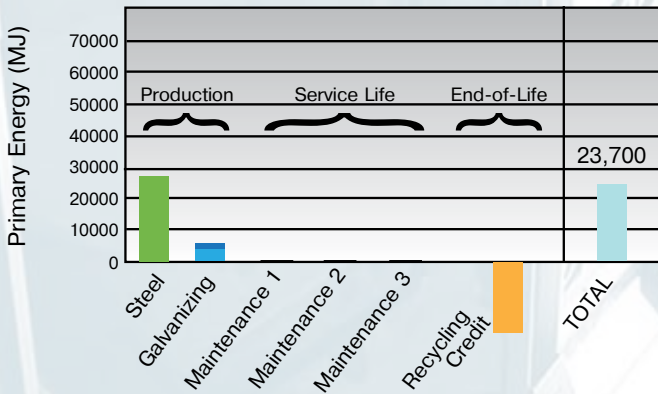
Figure 2

The total energy consumed during the production, use, and end-of-life phases for the hot-dip galvanized balcony is 23,700 MJ (30.5 MJ/kg) (*Figure 2*, next page). An identical painted balcony uses 64,700 MJ (83.2 MJ/kg) through all three phases, primarily because it must be maintenance painted every 15 years (*Figure 3*, next page).

Life-Cycle Energy: Galvanized

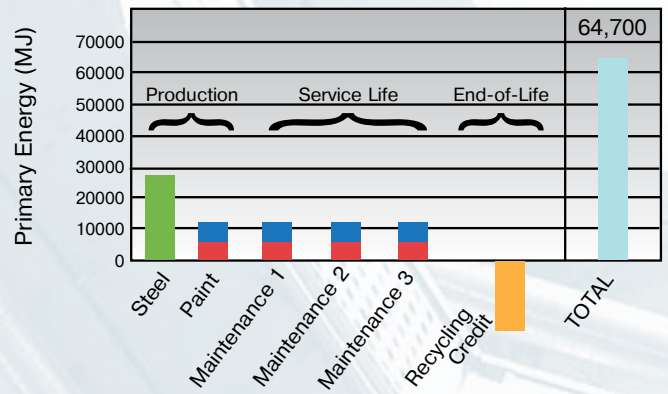
Figure 3

Life-Cycle Energy: Painted

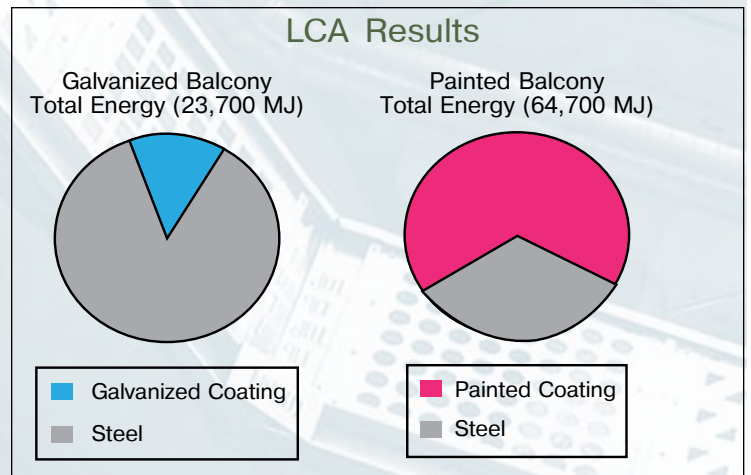
Figure 4

When analyzing just the hot-dip galvanized coating and the paint coating energy consumption as a percentage of the total energy consumed, it is clear the best choice is hot-dip galvanizing. To provide corrosion protection for 60 years, the hot-dip galvanized coating represents just 16% of the 23,700 MJ energy requirement of the balcony, compared to the paint coating's 69% of the 64,700 MJ consumption (Figure 4).

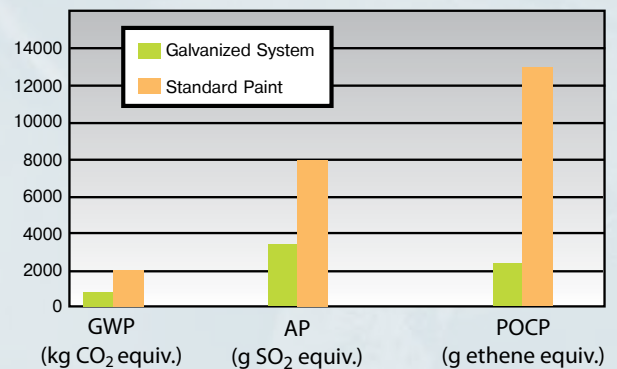
Figure 5

The output as measured by three key indicators for the entire 60-year life is an important consideration in corrosion protection system selection. In addition to assessing the energy input required to produce the balcony (raw materials + process) and that required in the use and end-of-life phases, Figure 5, below, shows the environmental impact of the hot-dip galvanized coating compared to the paint coating in terms of GWP, AP, and POCP (smog). For each indicator, hot-dip galvanizing has a fraction of the environmental impact of paint, primarily because the painted balcony requires periodic maintenance.

Impact Indicator LCA Results Full Life-Cycle
