Galvanized Steel in Water and Wastewater Infrastructure

PHILIP G. RAHRIG, *American Galvanizers Association*

Hot-dip galvanizing is an economical way to protect steel in atmospheric and submerged exposures. This article outlines the strengths and limitations of hot-dip galvanized (HDG) steel in water and wastewater service. It also describes the use of HDG steel in a wastewater plant.

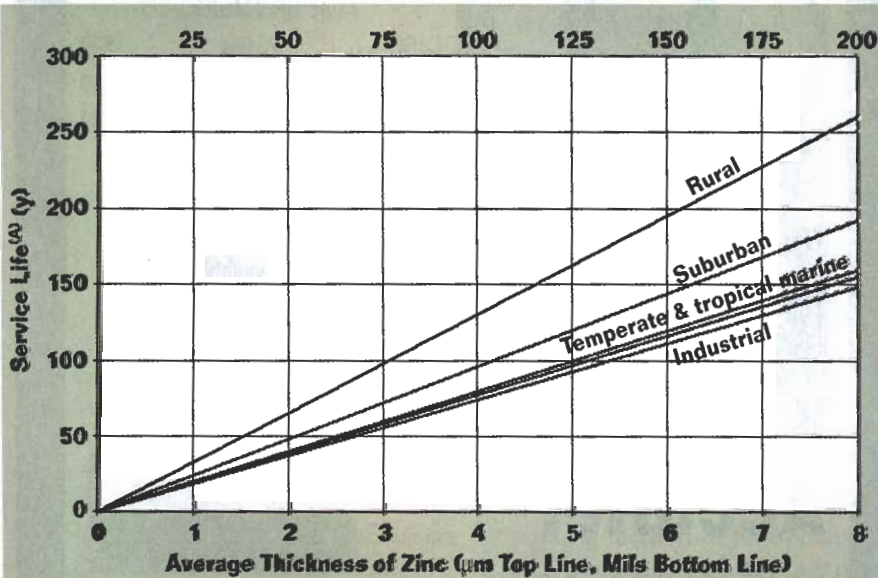
FIGURE 1

(A) Service life is defined as the time to 5% rusting of the steel surface. Note: 1 oz/ft² ~ 1.8 mils (46 µm)

Service life chart for HDG coatings in various environments.

Galvanized steel performs best when the zinc coating is permitted to react naturally with oxygen, hydrogen, and carbon dioxide (CO₂) in the air to form a stable zinc carbonate (ZnCO₃) patina film. In atmospheric exposure, this film is inert—not water-soluble—and generally is slowly removed over long periods of time only by the physical forces of abrasion and erosion (wind, water) or chemical reactions. In the case of atmospheric corrosion, thousands of galvanized structures have been tested over many decades. The life expectancy of hot-dip galvanized (HDG) steel can be accurately predicted in various atmospheric exposures (Figure 1). Factors affecting performance include sulfides and chlorides in the air. Figure 1 indicates that galvanizing can easily provide nearly maintenance-free corrosion prevention for 35 to 40 years in moist atmospheres.

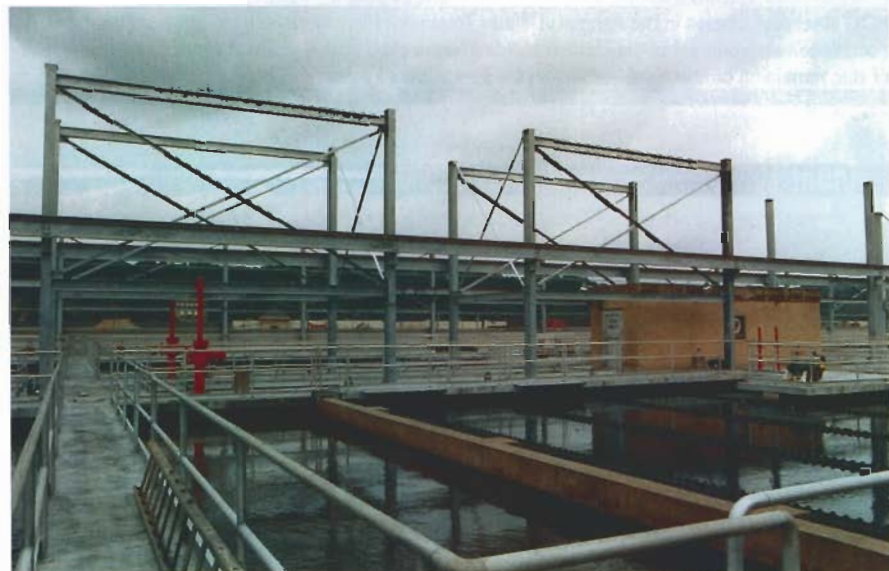
FIGURE 3

Aspinwall Water Treatment Plant under construction in 1989. HDG steel columns support the steel roof truss in the clarifier building.

In 1989, more than 250 tons (226,800 kg) of HDG steel were used in the columns and truss network covering the four-basin clarifier at the

Aspinwall Water Treatment Plant (Pittsburgh, Pennsylvania) (Figure 3). Harsh chemicals added to the clarifier (chlorine, alum, lime, and permanganate) accelerate corrosion of unprotected steel. A 1997 inspection of the galvanized steel measured 5 mils (127 μ m) of zinc—enough to last at least 50 more years (Figure 4).

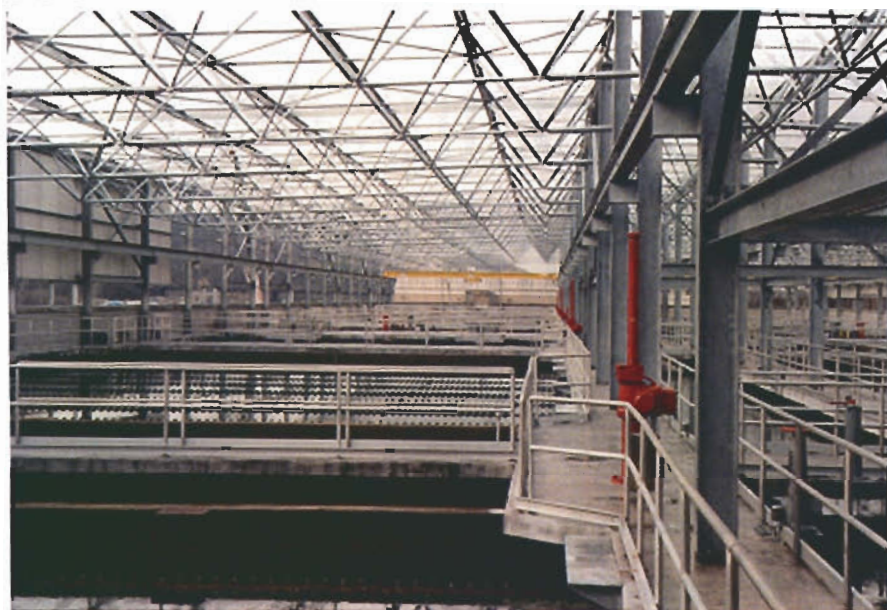
FIGURE 4

HDG steel roof trusses in the Aspinwall Water Treatment Plant were built to withstand the harsh flocculation environment of the clarifier building. Inspection after 8 years of service revealed 5 mils of zinc remaining on the steel—sufficient for 50 additional years.

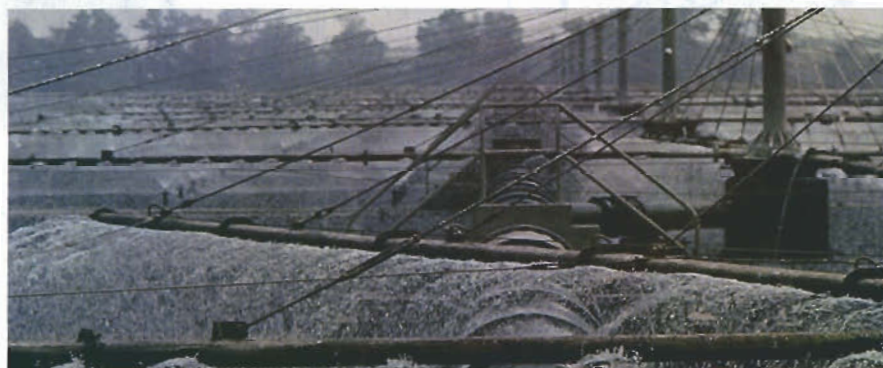
FIGURE 5

Backwater Wastewater Treatment Plant. HDG wiers in the settling tanks have been in constant service for 30 years.

The Back River Wastewater Treatment Plant (Baltimore, Maryland) (Fig-

ure 5), built in 1938 and designed to treat corrosive sludge and industrial wastes, has experienced more than 40 years of virtually maintenance-free service from HDG steel. Galvanized weirs in the settling tanks have seen continuous service since the day the plant opened. In the final settling tanks, weirs, brackets, and guide rails have remained in excellent condition for 30 years. In the trickling filter system, galvanized steel rotary distributors have been maintenance-free for more than

30 years as well. Moreover, the galvanized grit-removal gratings served 40 years before they required removal, regalvanizing, and reinstallation.
