Question of the Month

Q: What kind of service life can be expected from a painted overhot-dip galvanized coating, and is there a cost savings?

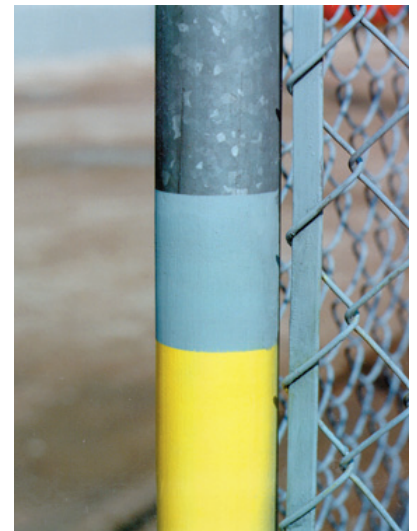
A Duplex System
