ASK DR. GALV

Q Area contractors have recently been using epoxy-coated rebar in many newly-constructed bridges. I know HDG is a superior coating, but in what areas does it really outshine epoxy?

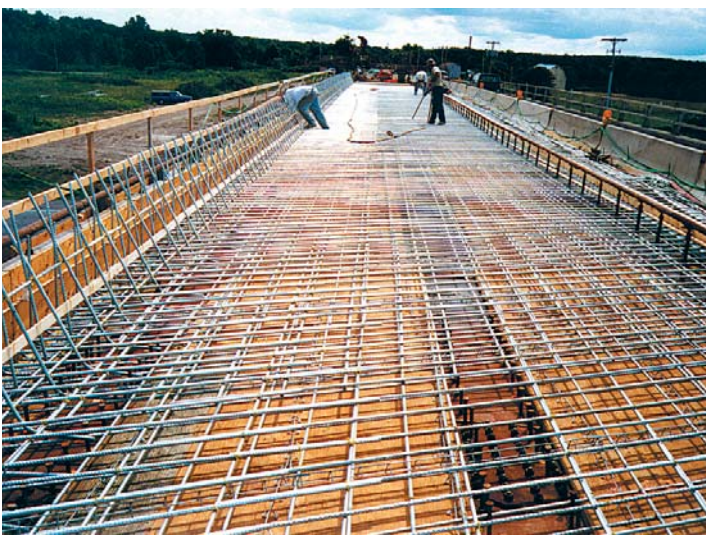
A Hot-dip galvanized steel's superior corrosion protection can easily be recognized when a simple evaluation of field performance is reviewed. HDG reinforcement has been used since the 1950s . . . One of the earliest examples of this is the Long Bird Bridge in Bermuda, constructed in 1953. Bermuda is classified as a marine environment, which is subject to high chlorides levels and, consequently, elevated corrosion rates for steel materials. A 1978 inspection of the this bridge by the Construction Technology Labs found that chloride levels in the concrete reached up to 7.3 lbs/yd³ (4.3 kg/m³). High chloride levels accelerate corrosion rates by locally lowering the pH at a corrosion site. A cross-sectional chloride analysis of the concrete section pointed that the cement was probably made up with seawater, introducing high levels of chlorides, immediately contacting the HDG rebar. Nevertheless, the galvanized coating shows only slight signs of corrosion (98% intact) even after almost 50 years in service under aggressive environmental conditions.
