New York City Bus Shelter

New York City, New York

transportation

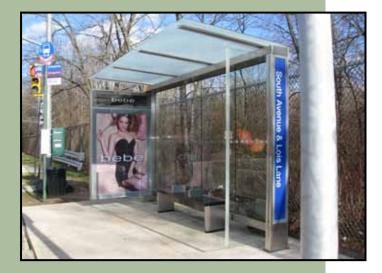
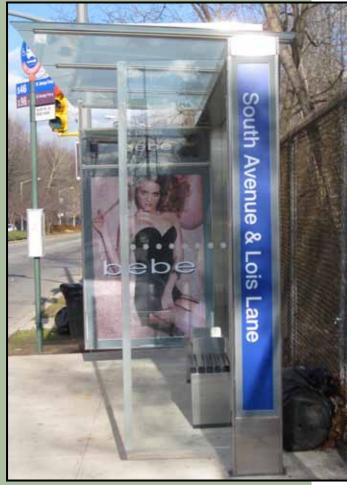
Visible to the millions of passengers that pass by every day, the galvanized steel of the New York City Bus Shelters stand corrosion-free under the daily hardships of life on the New York streets. With the constant onslaught of sun, rain, snow, road chemicals, and pollutants, painted steel would be "cracking" under the pressure.

All 500 tons of structural steel members, including tubing and side and roof panels, required a smooth finish, free of zinc build-up and smooth to the touch. With truckloads of steel coming in from multiple

steel suppliers, no other coating could have been applied as quickly. The quick turnaround of the factory-controlled hot-dip galvanizing process allowed the galvanizer to match the different components together and ship them to the different sites complete and fast.
